The Da Nang Glider
Larry Westin - March 16, 2001
Updated Rev. C - 12/04/14 - Page 1 of 6

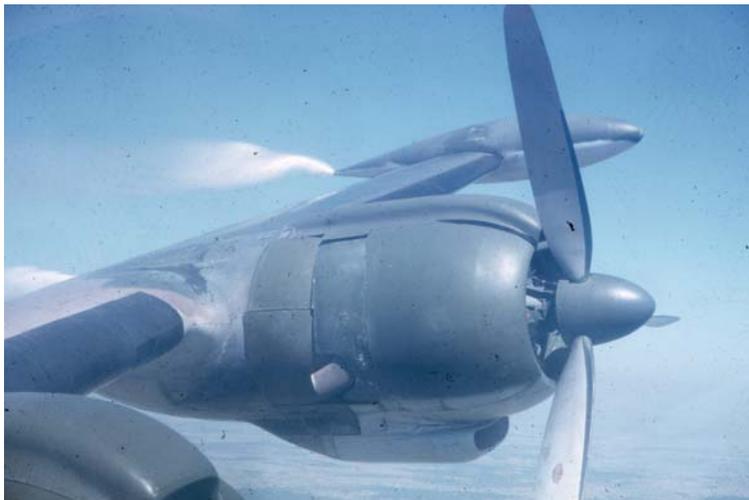
power, to prevent the airplane from maintaining altitude, if the landing gear and flaps are down. Image at left shows the propeller on the number 1 engine feathered. When an engine was lost it was most times necessary to reduce the weight of the airplane by dumping fuel. In this photo you can see fuel being dumped from immediately behind engine #1 and also from the left tip tank.

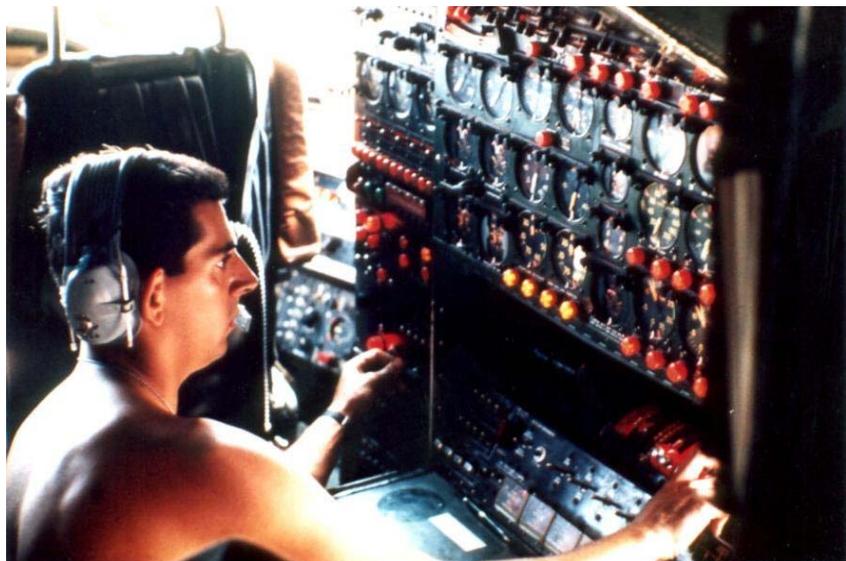
This view of the flight engineers panel was taken during a ground run up of a replacement engine. Note at the bottom of the panel there are 4 plastic guards which prevent accidental feathering of a propeller. The flight engineer had to raise the plastic guard, then push the feather button. When the button was depressed a bright red light illuminated.
